STRESS-CORROSION CRACKING
OF HIGH-STRENGTH ALLOYS

Report No. 0414-01-8 (Quarterly)

February 1963

AEROJET-GENERAL CORPORATION

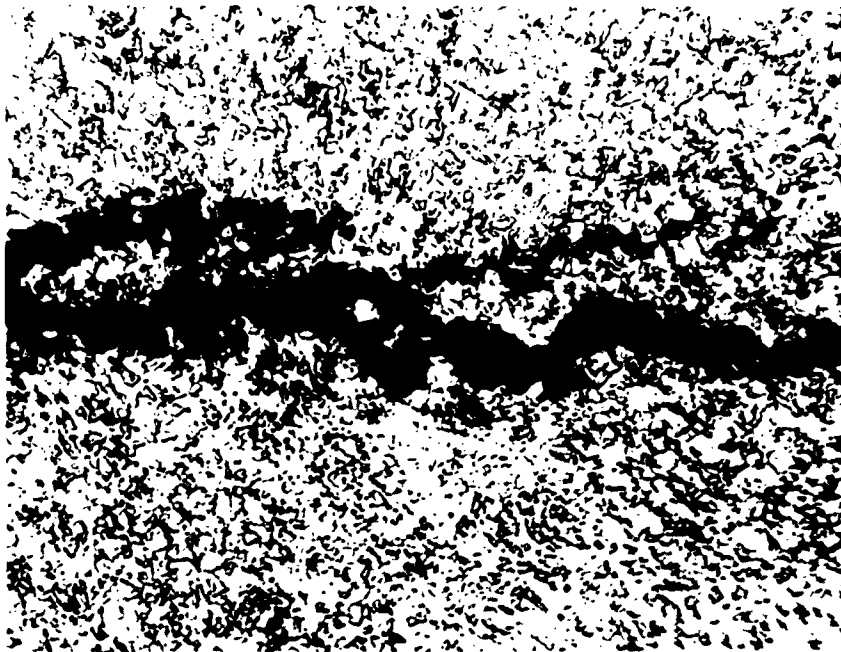
Crack Pattern on Surface of Beam Sample after 10 hours in Aerated Distilled Water. (5X)

Vertical View of Cracking in Above Sample Showing Intergranular Cracks. Etchant is Diluted Marbles Reagent (1000X)

Stress-Corrosion Crack Pattern on 20%-Nickel Maraging Steel

Examination of the cracked specimens shows a branching crack pattern, as illustrated in Figure 5. The same figure also shows a photomicrograph of a crack which indicates cracking to be intergranular in nature.

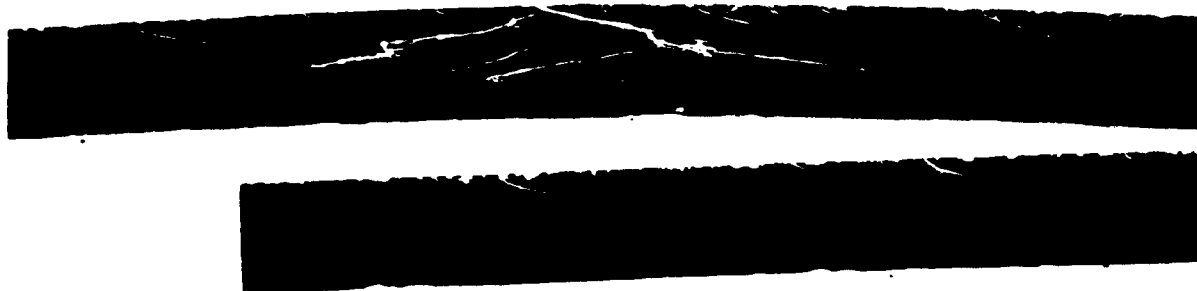
Surface of Cold-Worked-and-Aged 18%-Nickel Maraging Steel After 10-Days at 140°F in High Humidity Stress Corrosion Test. Surface has been Wire-Brushed. (Approx. 2X)

Cross-Section of Above Sample Showing Possible Cracking Along Slip Planes. (10X)

Figure 7 shows the cracking pattern on the surface of a cold-worked-and-aged, 18%-nickel, bent-beam specimen after 10 days in water-saturated air, at 140°F. It depicts the multiple cracks which developed across the width of the specimen. Curiously, the direction of propagation down through the specimen thickness (shown in the bottom panel of Figure 7) is at a sharp angle from the perpendicular, forming a cross-hatch pattern; such a crack pattern is sometimes indicative of a slip-plane mode of cracking, although the information at present is insufficient to definitely establish this fact. Figure 8, a photograph, made at greater magnification, of some of these cracks indicates initiation of branching cracks developing perpendicular to the main fracture lines.

The nature of these cracks will be further investigated to determine whether the fractures actually occur along Widmanstätten lines (indicating heat-treat or cold-working dependency) or along slip planes (indicating intercrystalline structural weakness). Residual stress measurements will be performed by X-ray diffraction methods to determine the critical stress level, and optical and electron fractography studies will be performed on the fracture surfaces to indicate the microstructural changes associated with the cracking process. A detailed examination of the cracking pattern will also be made to establish whether cracking is intergranular or transgranular in nature.

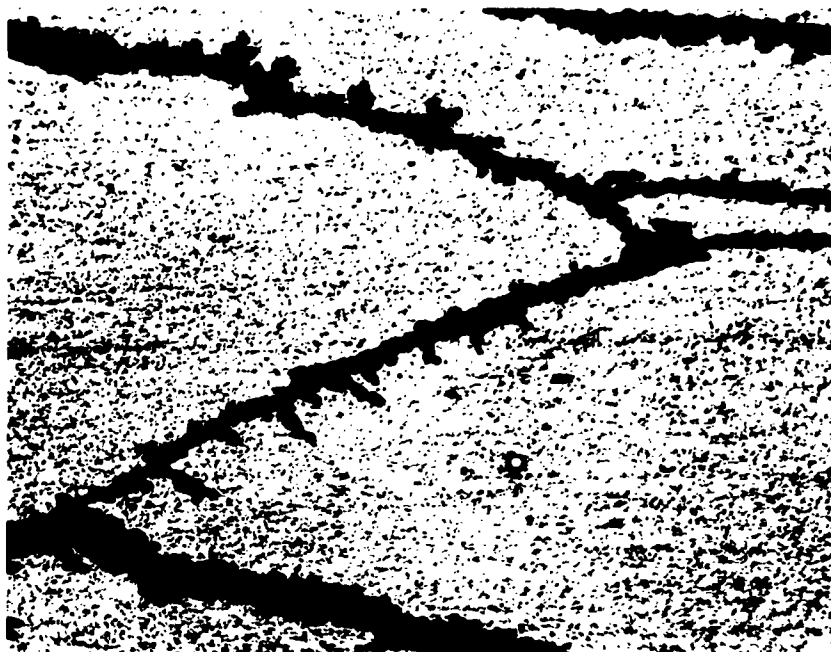
View of Surface in Lightly Cracked Area Showing Pitting Attack (100X)

General Structure in Interior of Highly Cracked Area.
Etchant - 10% Ammonium Persulphate-electrolytic. (500X)

Photomicrographs of Stress-Corrosion Cracking in 18%-Nickel Maraging Steel
